Maintenance & Servicing Guide

Harmony 13,23,33,43

Stanford 13,23,33

IN1195 Edition E March 2020

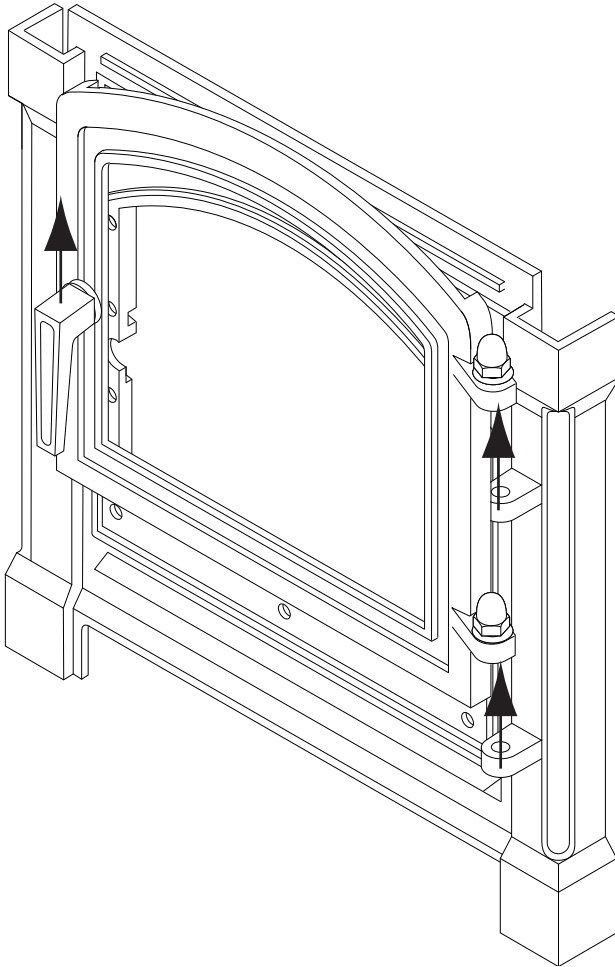
Open door and lift upwards holding hinge side of door and the handle.

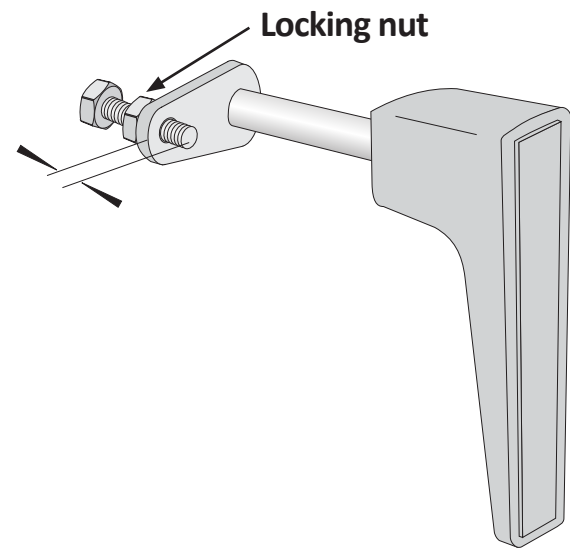
Handle Latch Adjusting

It is best to soak the bolt and nut with a penetrating oil for a few minutes before trying to adjust them.

To adjust the furnace door handle latch, loosen the locking nut and adjust the bolt as required. Re-tighten the locking nut. The adjustment should be made so that when the handle is in its closed position the door is air tight.

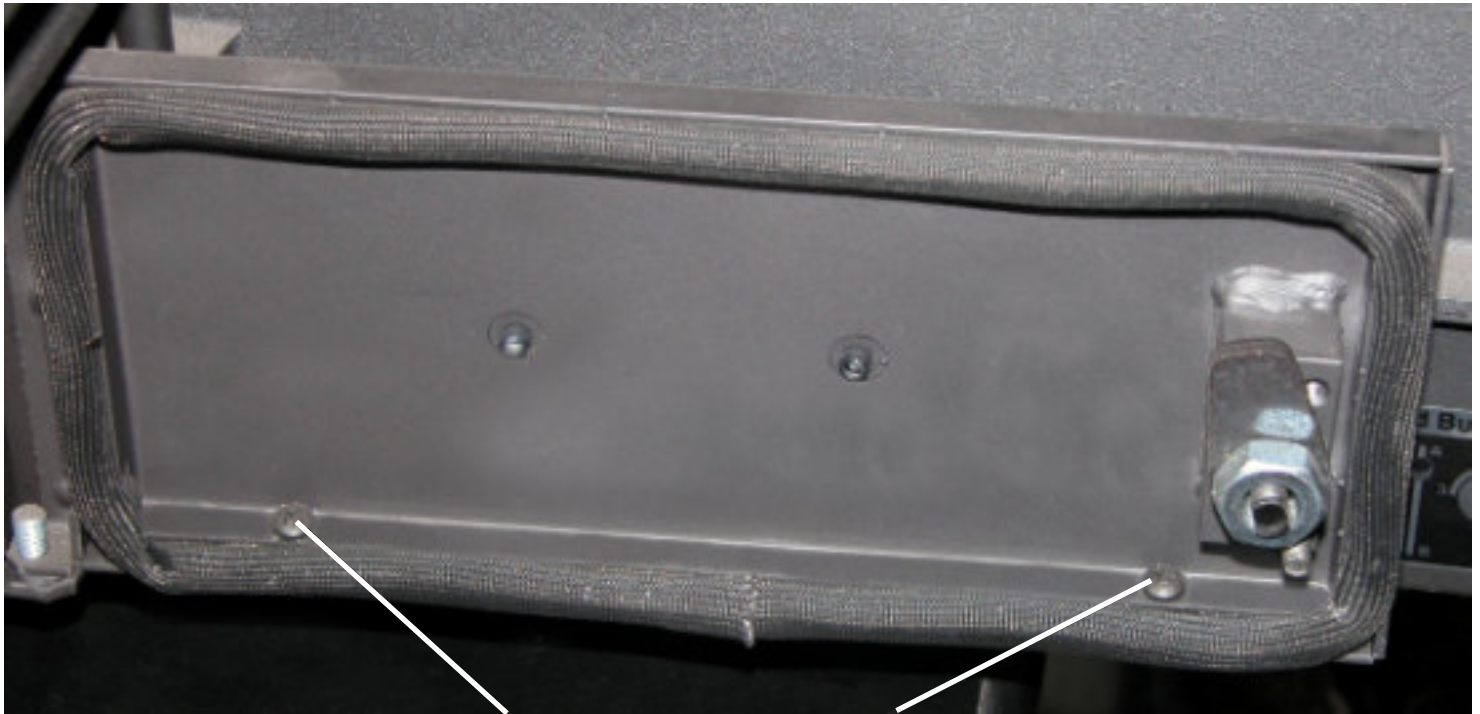
**Self Tapping
Retaining Screws**

The hollow rope in the seal set kits is cut to an approximate length, as the kits fit various stoves. Run the rope around the rope groove and cut it longer than is required by about 20mm so that one end can be tucked into the other to make a good seal. Remove it from the groove and apply a bead of rope glue into the rope groove. Push the rope back into the groove ensuring that the joint is at the top and fitting tightly together. Replace any self tapping screws that you may have been removed to take out the old rope seal. Close the door and adjust the handle latch accordingly.

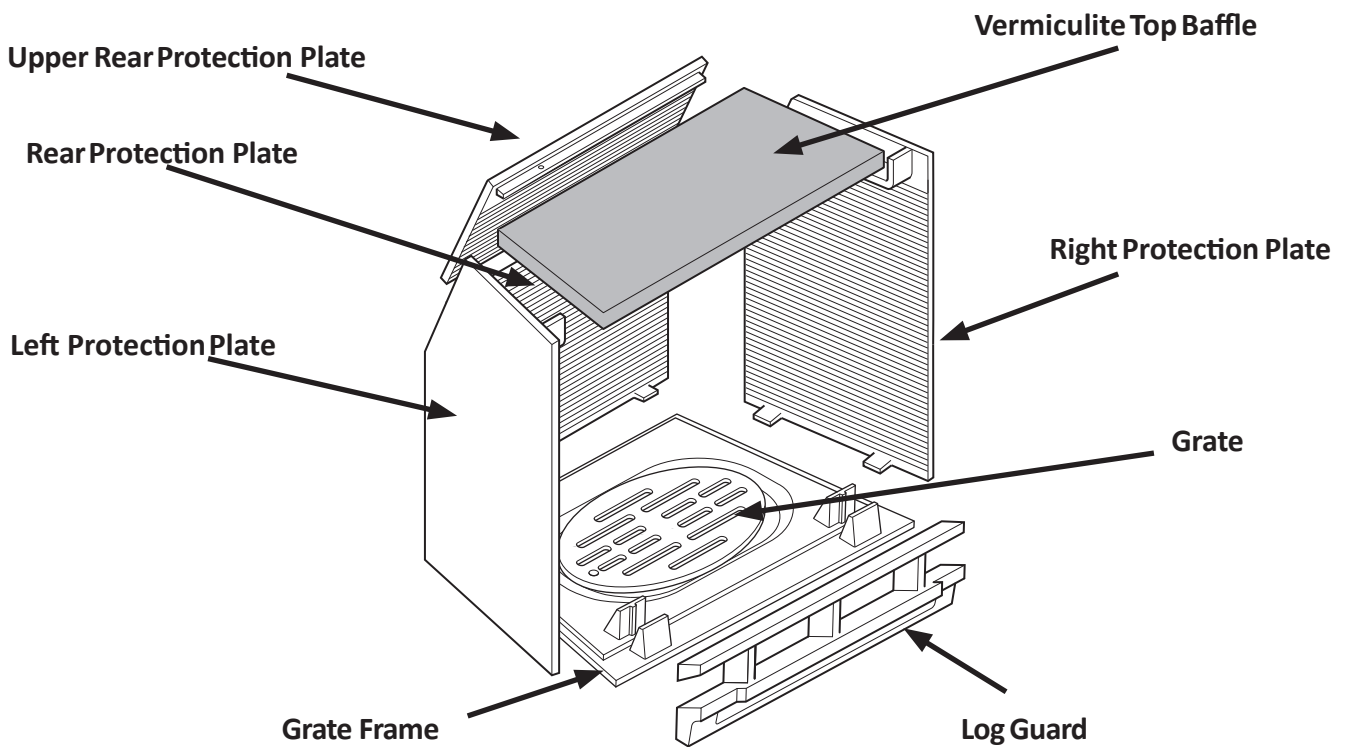
Harmony 23/33/43, Stanford 23/33 and SP23/33 Firebox Components

Firebox Size	13	23	33	43
Description	Part No.			
Grate	47311	38256	38256	38262
Grate Frame	32796	44098	42294	42937
Right Side Cheek	32798			
Left Side Cheek	32798			
Upper Rear Protection Plate	43537	44100	43491	
Rear Protection Plate	43539	44102	43526	43938
Right Protection Plate	43535	44106	43530	42929
Left Protection Plate	43541	44104	43528	42931
Vermiculite Top Baffle	MS9203	MS9189	43519	MS9213

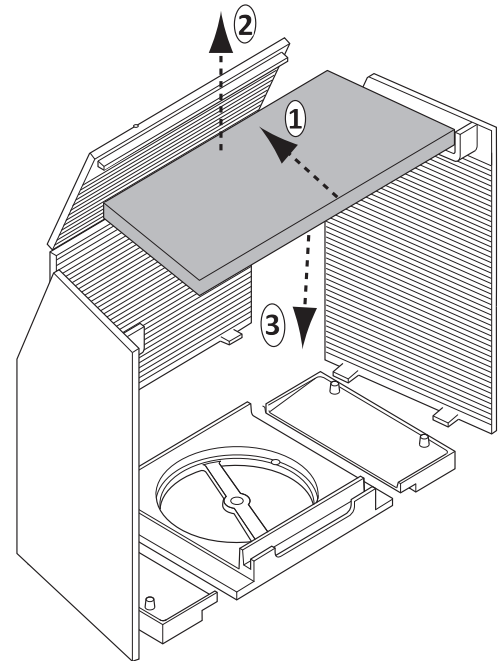
For easier access remove the front fuel guard. To remove (1) lift the front of the baffle board upwards above the height of the locating lugs (2) whilst lifting the front of the board slide it towards the front of the fire box. The rear edge of the baffle does not quite fully pass the front edge of the upper rear protection plate (3). This should be pushed back at the top to allow the rear of the baffle to be dropped down, (4) allowing the baffle to be pulled down into the main body of the fire box. It can then be angled to withdraw it through the door.

To refit the replacement reverse the procedure. If the new baffle seems to be a little tight then cut off a small amount from the length of the board with a fine toothed wood saw, generally 2mm will be enough.

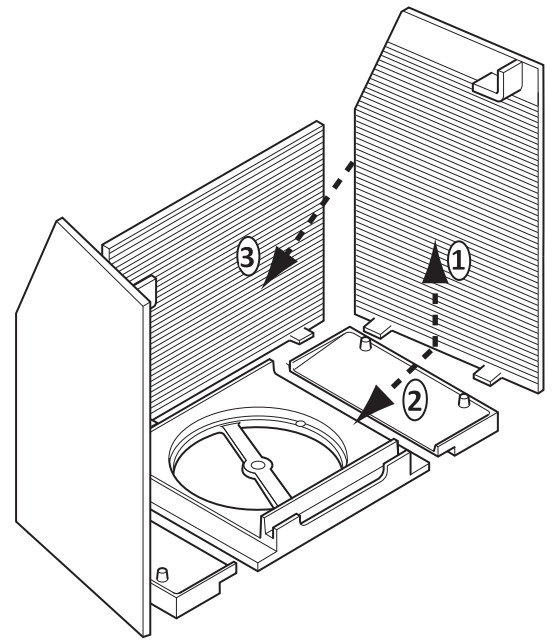
Removal of the Rear Protection Plate H13 & S13

To remove (1) lift up the plate so it is higher than the lugs on the grate frame and then (2) draw it towards the centre of the fire box.

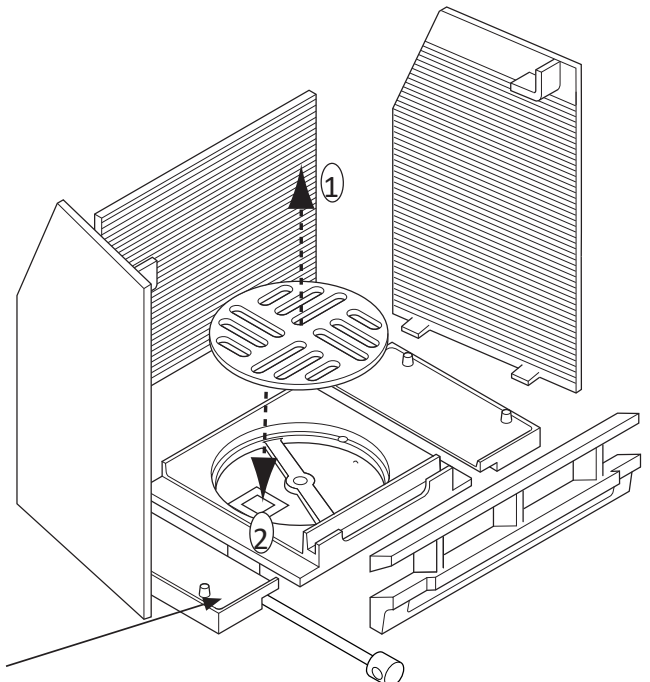
Cast Iron Grate Side Cheek
with the Lugs Uppermost

With the baffle plate, log guard and side protection plates removed. Lift out the two cast iron bottom protection plates from either side of the grate frame. The grate frame can then be lifted out of the stove. When refitting the cast iron bottom protection plates ensure that the lugs are upwards.

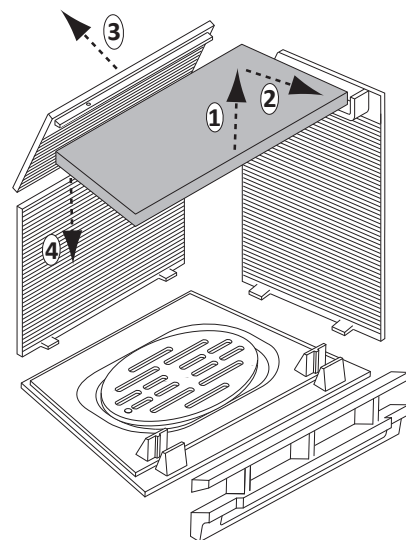
The top mica baffle is located in the top of the fire box where it sits on the L shaped baffle support lugs which are part of the casting of the left and right side protection plates. For easier access remove the front fuel guard. To remove (1) lift the front of the baffle board upwards above the height of the locating lugs (2) whilst lifting the front of the board slide it towards the front of the fire box. The rear edge of the baffle does not quite fully pass the front edge of the upper rear protection plate. (3) This should be pushed back at the top to allow the rear of the baffle to be dropped down, (4) allowing the baffle to be pulled down into the main body of the fire box. It can then be angled to withdraw it through the door.

To refit the replacement reverse the procedure. If the new baffle seems to be a little tight then cut off a small amount from the length of the board with a fine toothed wood saw, generally 2mm will be enough.

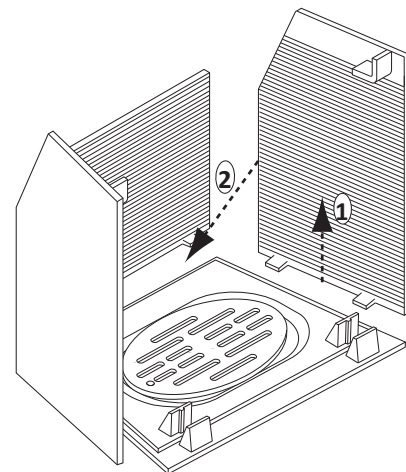
Removal of the Rear Protection Plate H23, S23 & SP23

To remove (1) lift up the plate so it is higher than the grate frame and then (2) draw it towards the centre of the fire box.

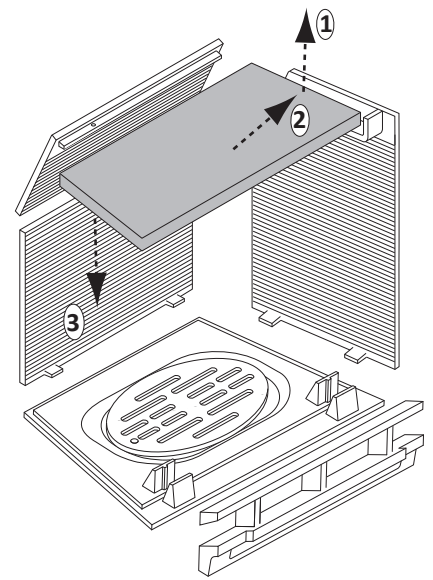
The top mica baffle is located in the top of the fire box where it sits on the L shaped baffle support lugs, which are part of the casting of the left and right side protection plates. For easier access remove the front fuel guard. To remove (1) lift the left or right hand side of the baffle board upwards as far as it will lift. (2) Slide it to that side so it moves clear of the lug on the other side and (3) then drop it down into the fire box. It can then be angled to withdraw it through the door.

To refit the replacement reverse the procedure. If the new baffle seems to be a little tight then cut off a small amount from the length of the board with a fine toothed wood saw, generally 2mm will be enough.

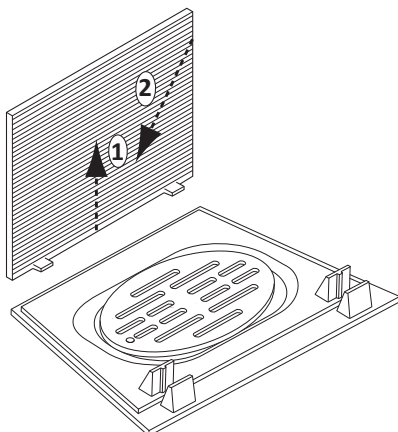
Removal of the Rear Protection Plate H33,43, S33,43 & SP33

To remove (1) lift up the plate so it is higher than the grate frame and then (2) draw it towards the centre of the fire box.

As it is drawn towards the centre twist the edge towards the front of the fire box. It can then be angled within the fire box to withdraw it through the door.

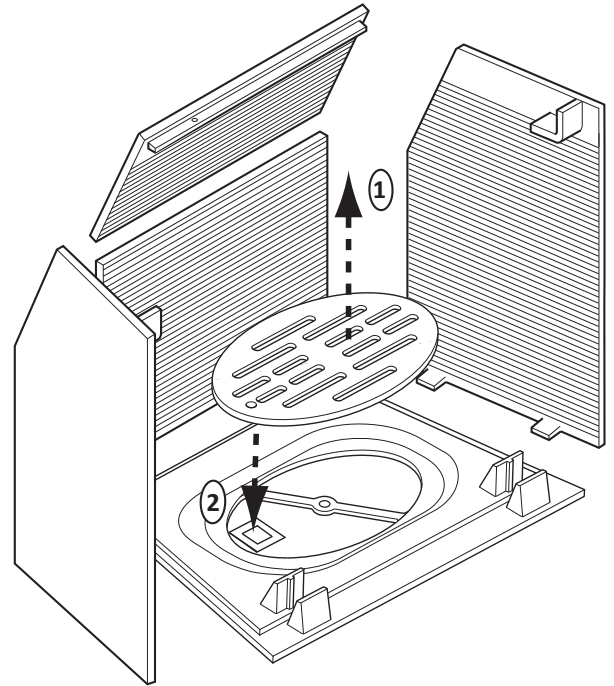
Removal of the Grate Frame.

With the baffle plate, log guard and side protection plates removed. Lift out the grate. The grate frame can then be lifted out of the stove.

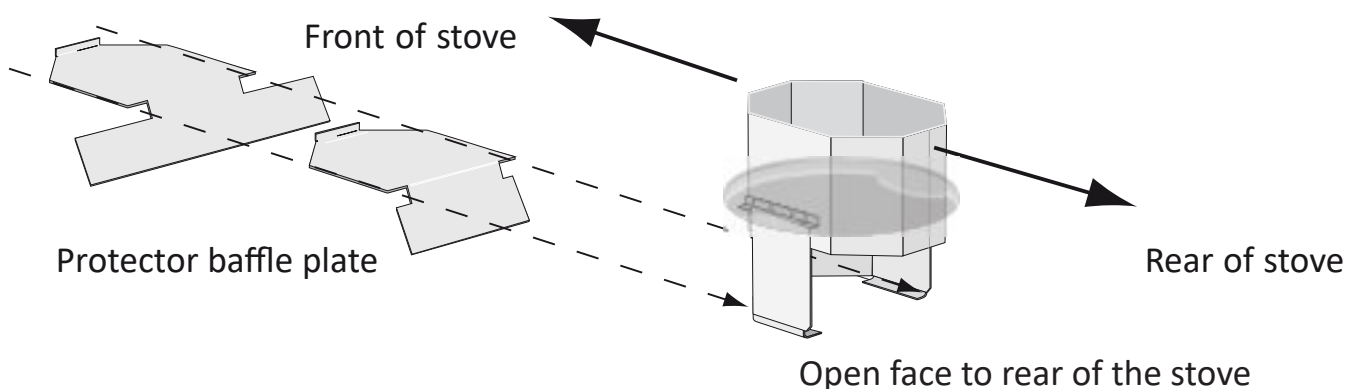
Harmony 13 & Stanford 13 Mk2 Top Flue Baffle

The winged baffle slides out of the octagonal flue protection collar by pulling it towards the front of the stove. To replace the baffle slide it back into the octagonal collar until the small raised lip touches the front face of the collar. The wing should be pointing downwards and towards the back of the stove.

Note: The winged baffle plate is not fitted to the H43 and none of the assembly is required when the stove is utilising its rear flue option.

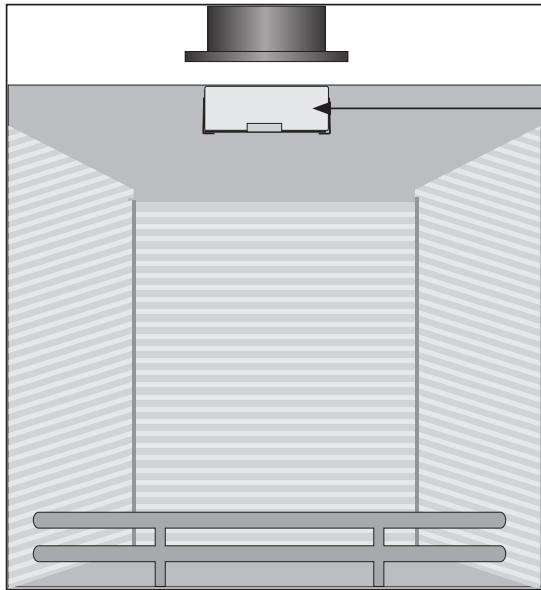
The flue baffle is fixed to the top of the stove below the flue outlet.

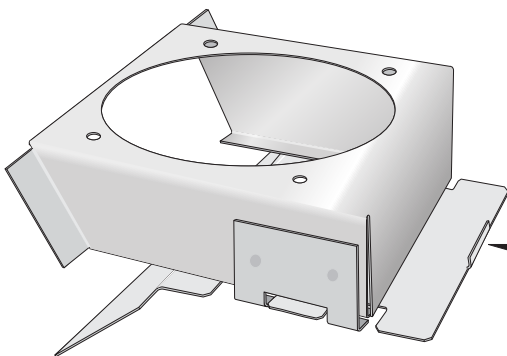
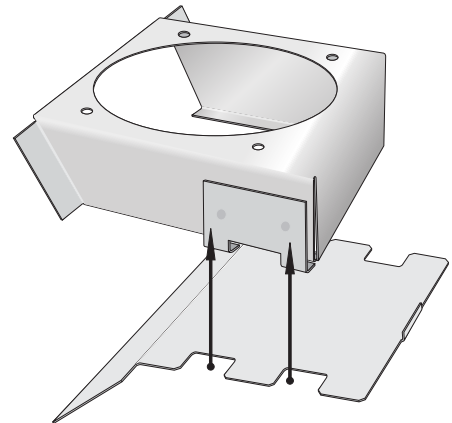
Lift the flue baffle plate up to the flue baffle. The wing towards the back of the stove and with the wing angled downwards. The lugs on the flue baffle plate should be located in the cut out on the base of the flue baffle.

Once the lugs have been located into the cut out on the base of the flue baffle, slide it towards the back of the stove until it is fully pushed in.

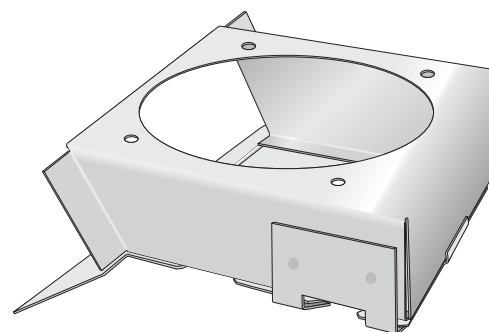
The baffle plate is in the correct position when the small upturn on the baffle plate is against the facing wall of the flue baffle.

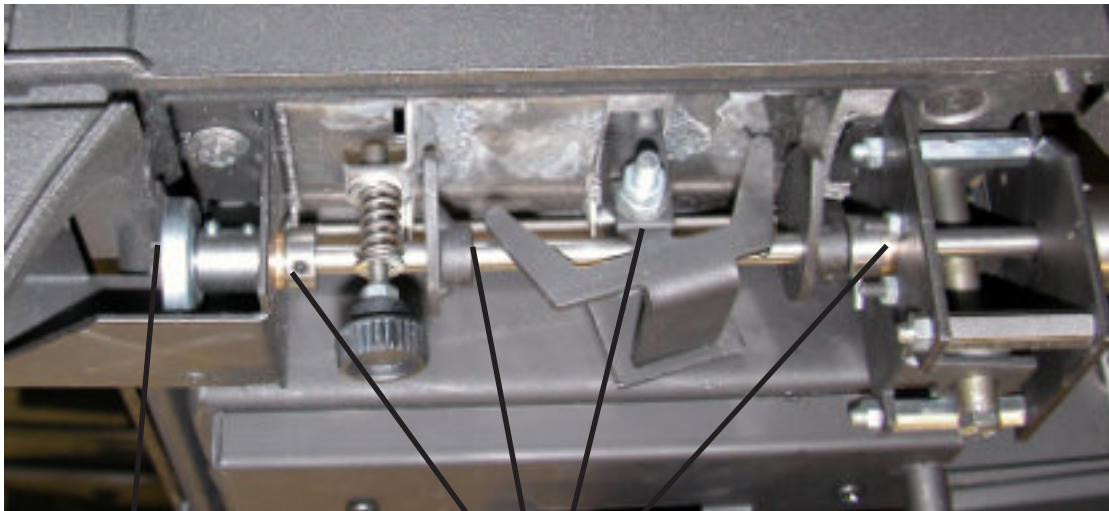
The unit itself needs very little maintenance other than a small amount of lubrication if the controls become stiff. A light oil, such as WD40, is all that is required and can be applied whilst the plexus unit is fitted to the stoves body. The picture below shows the points at which the oil should be to be applied.

Point where a small amount copper grease can be applied.

Points where a small amount of a light oil can be applied.

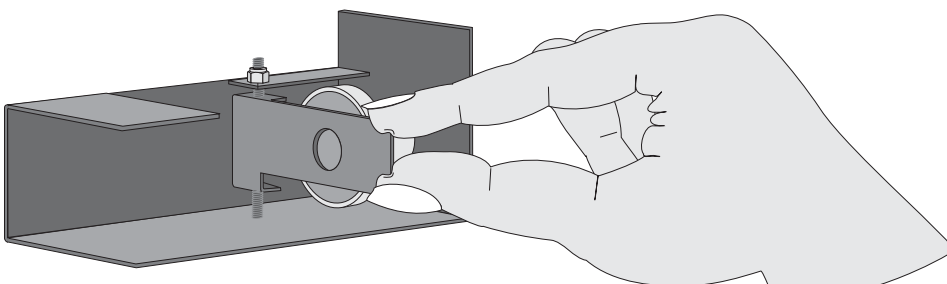
If there is no motor push away the gate and apply a small amount of copper grease to the face of the magnet before allowing the gate to swing back onto the magnet. If there is a remote motor fitted slide it back enough to allow the application of a small amount of copper grease.

Gate covering the magnet face

Push the gate away from the magnet

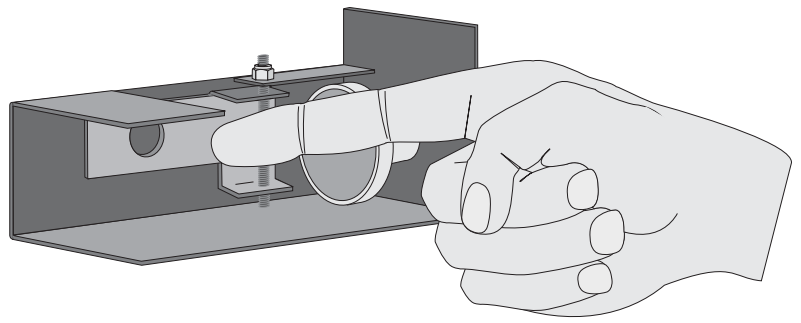
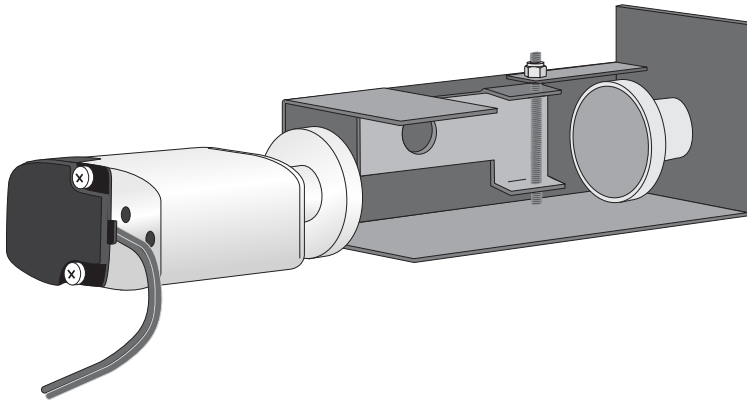
Slide the motor away from the magnet

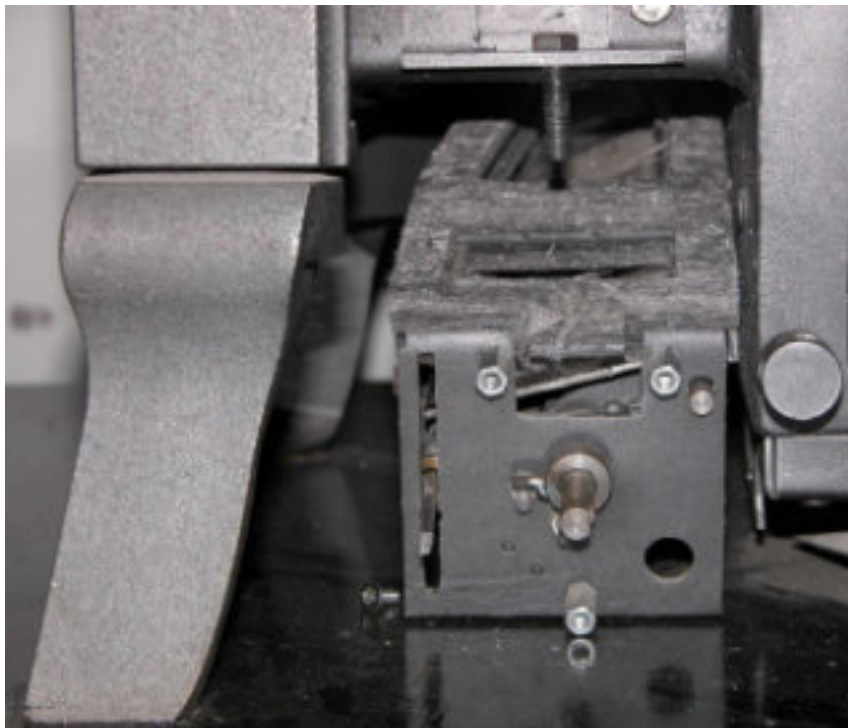
5) Drop the Front of the Plexus Down

Once the bolt has been removed the front of the plexus unit can then be lowered down and slid forward to remove it from the body of the stove.

If the ceramic felt gasket is damaged this will need to be replaced or air will leak in causing uncontrolled combustion.

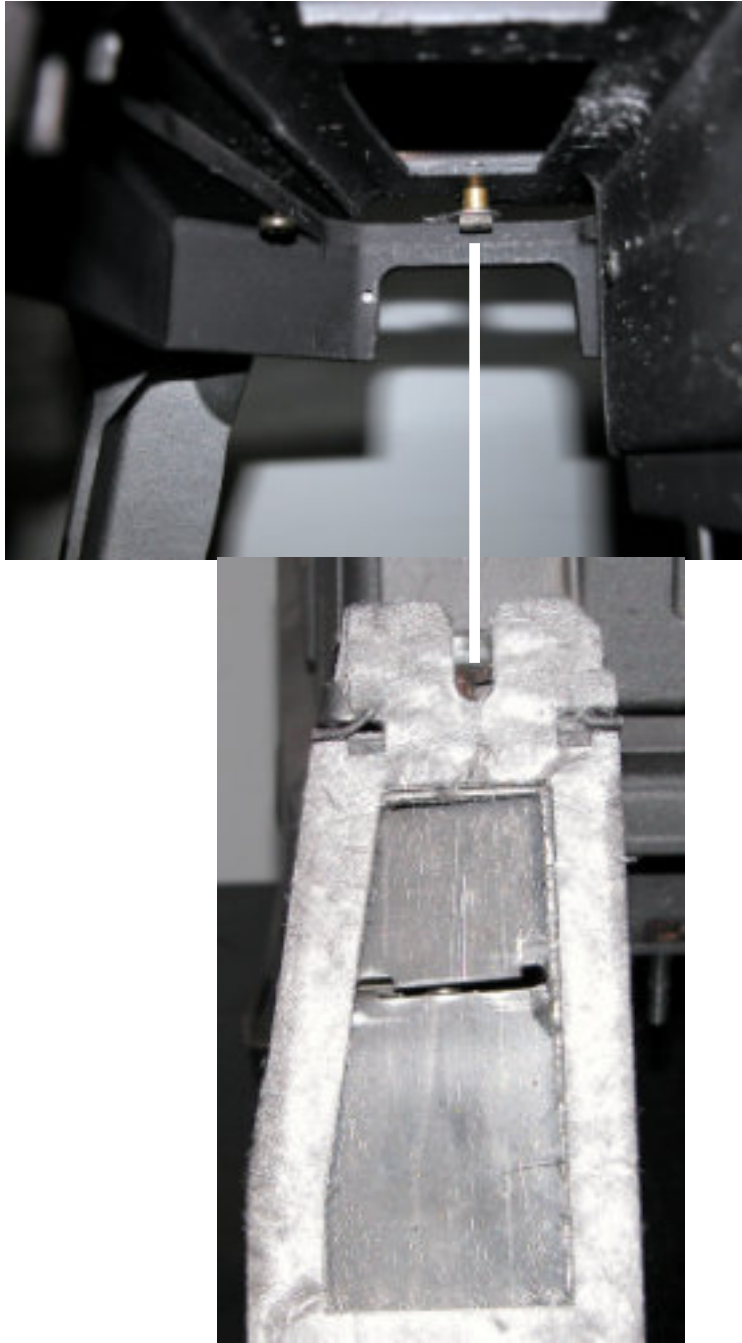
6) Replacing the Plexus Air Control

To fit the plexus control back onto the stove the locating slot on the rear of the unit should be slid onto the locating bolt at the rear of the stove, see pictures below.

Once the plexus is in position replace the front retaining bolt to hold the unit in place. The fascia plate and both control knobs can then be fitted.

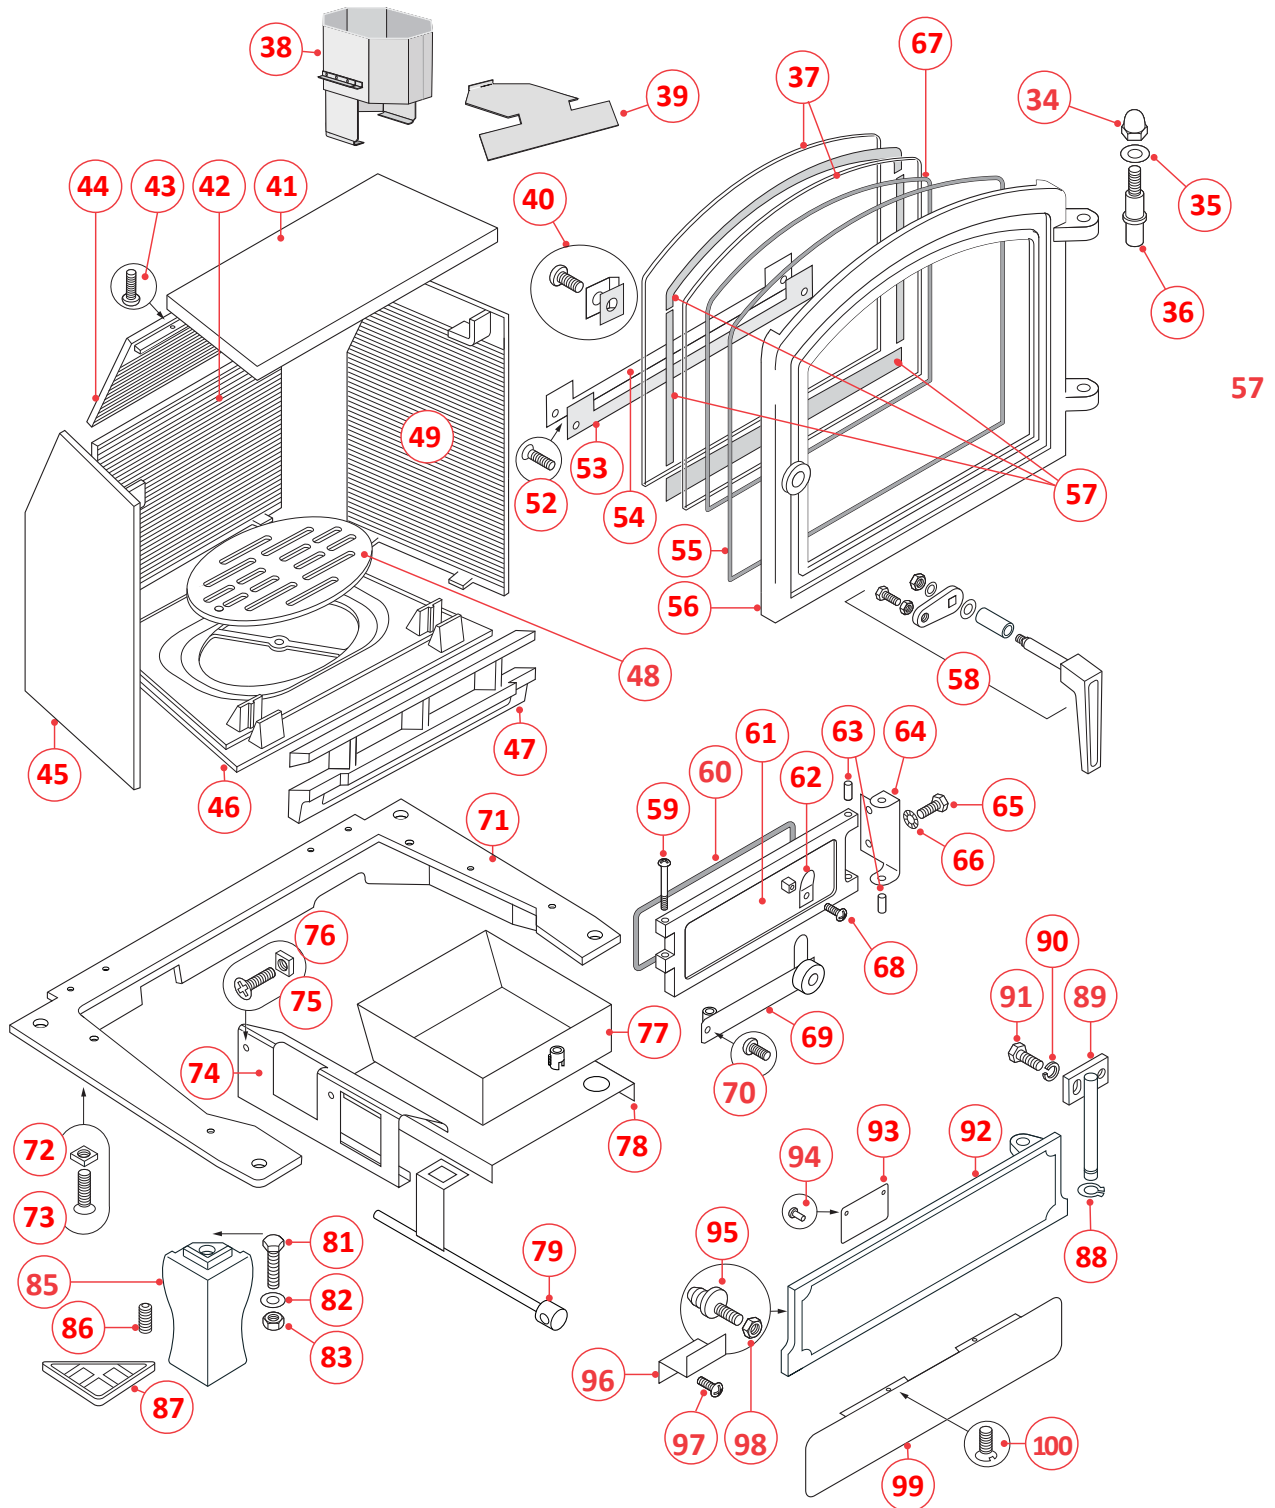
Below is an example of one the pages of spare parts diagrams you will find on our web site. These detailed drawings allow you to identify all the component parts of the stove. If you click on the numbers within the circles it will give you the part number and the price and availability of each item. These can then be ordered through your nearest retail outlet or online.
